Sunset Property Inspection

Confidential - Property Inspection Report - Confidential

4684 Biona Drive
Inspection Prepared For: John Kenster
Agent: -

Date of Inspection: 7/14/2021
Year Built: 1925 Size: 1296

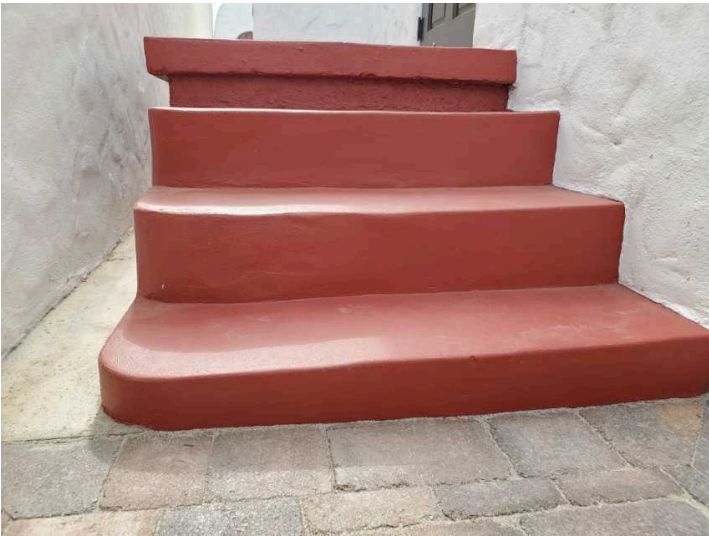
- Missing Hand Rails. There are currently no hand railings for the stairs inside the home. Stairs are the most frequent location of injury accidents in the home. For safety reasons it is recommended that handrails be provided for stairways with 4 or more steps. Handrails should be located at a height of 34-38 inches from the floor and should have a graspable surface between 1.25 inches and 2 inches. Recommend that handrails be provided at this location.
- Differing Riser Heights. The rise of the steps at the exterior of the home are not of equal height. The rise of the steps should not be: less than 4 inches, nor more than 8 and should not carry a difference between the two of more than 3/8 inch. This could pose as a trip hazard, and it is recommended that this is repaired.

Differing riser heights

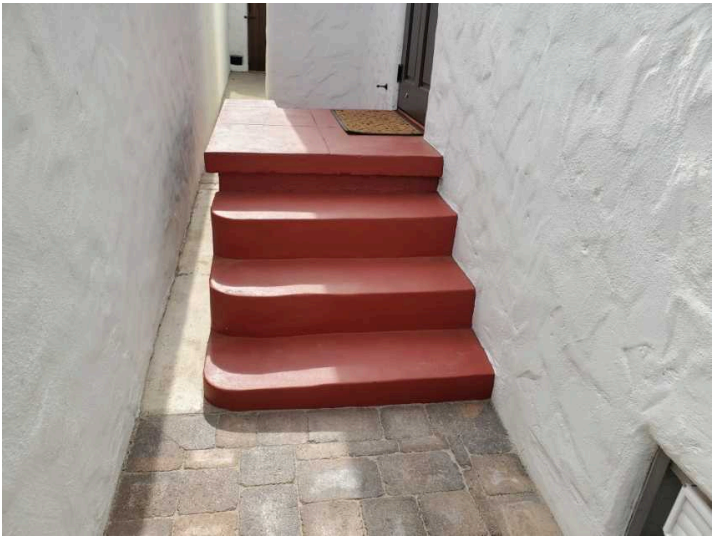
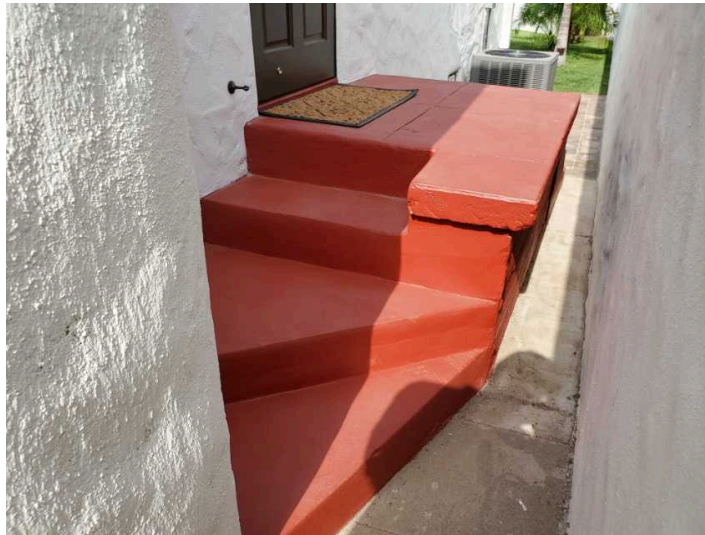
Handrail missing

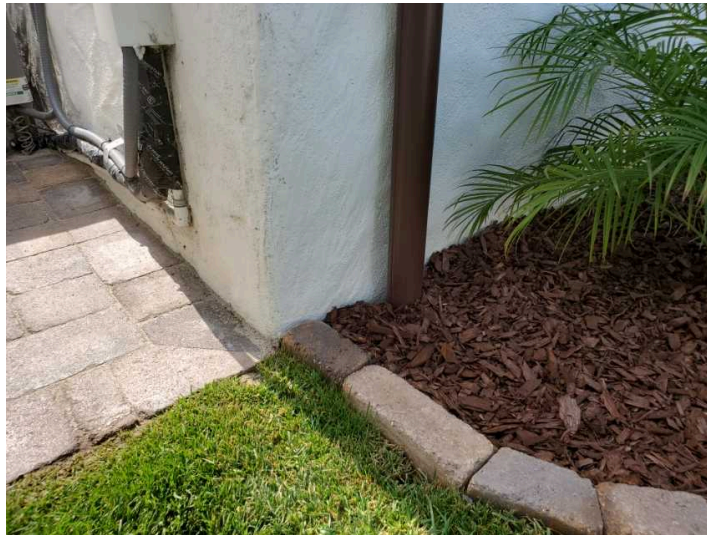
- Stucco on older homes built prior to the 1970's were installed without a weep screed. Since the stucco traverses the junction of the concrete foundation and the wood frame walls, a horizontal crack is common. This is due to the inevitable movement of the walls in relation to the concrete foundation. This crack is unlikely to cause damage if it remains small. Patching this crack is a temporary measure. Installing a weep screed will be needed to avoid cracking. The Weep screed flashing will allow for movement between the wood frame wall and the foundation stem wall. (The weep screed is a metal band at the bottom of the stucco.) We recommend installing a weep screed by a licensed stucco repair contractor.

- No weep screed visible or improper clearance to soil/concrete. The present standard distance is 4" to soil and 2" to concrete. Weep screeds are necessary for proper moisture drainage from behind stucco and prevent premature deterioration to the stucco, framing or moisture entry into the interior. We recommend correcting the condition(s) noted.

No weep screed

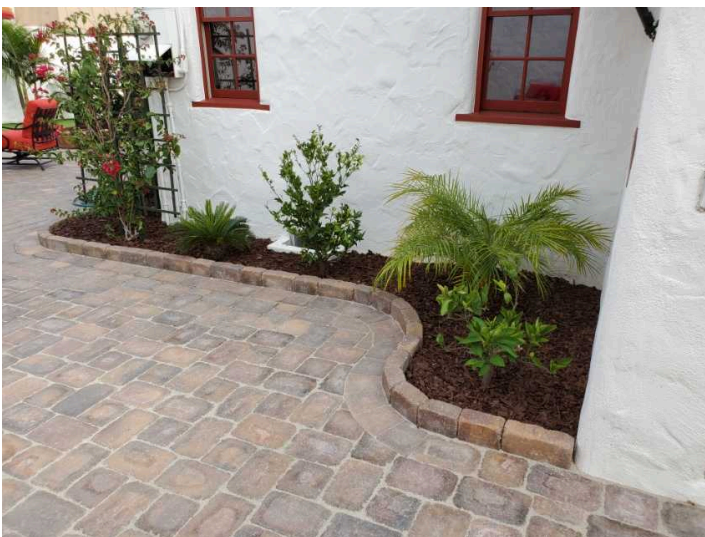
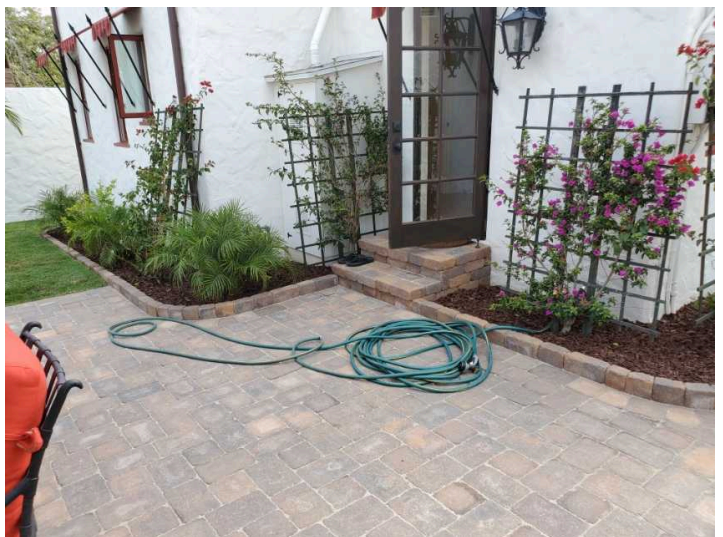
- Lot grading and drainage have a significant impact on the building, simply because of the direct and indirect damage that moisture can have on the foundation. It is very important, therefore, that surface runoff water be adequately diverted away from the home. Lot grading should slope away and fall a minimum of one (1) inch every foot for a distance of six (6) feet around the perimeter of the building. A soil gradient sloping away from the foundation was not established. The soil gradient was essentially flat at planter beds and/or lawn areas next to the foundation. Correcting the soil pitch is needed to improve drainage so that surface drainage is directed away from the foundation.

Poor drainage

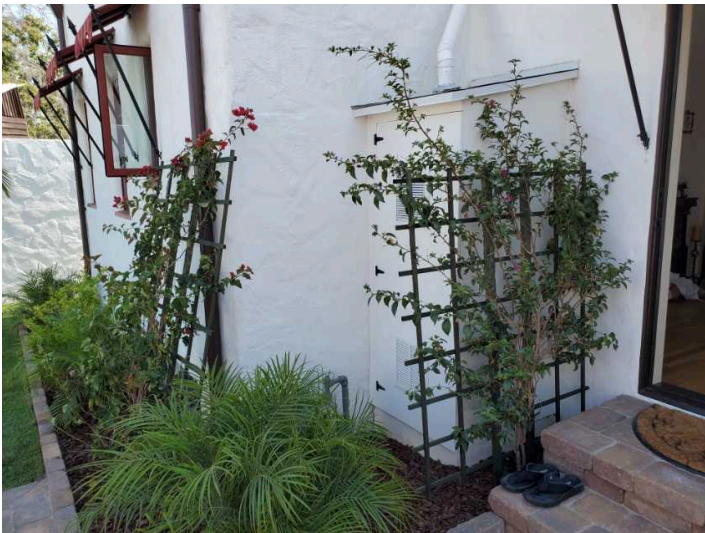
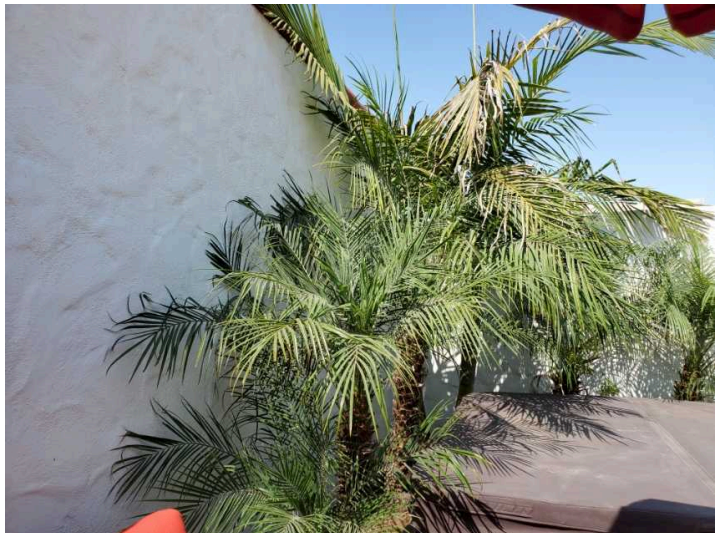
- Vegetation too close to the building can cause harm through root damage to the foundation, branches abrading the roof and siding, and leaves providing a path for moisture and insects into the home.
- Recommend having vegetation trimmed, pruned, or removed from affected areas, and regular homeowner monitoring and landscaping maintenance thereafter.

Vegetation in contact with house

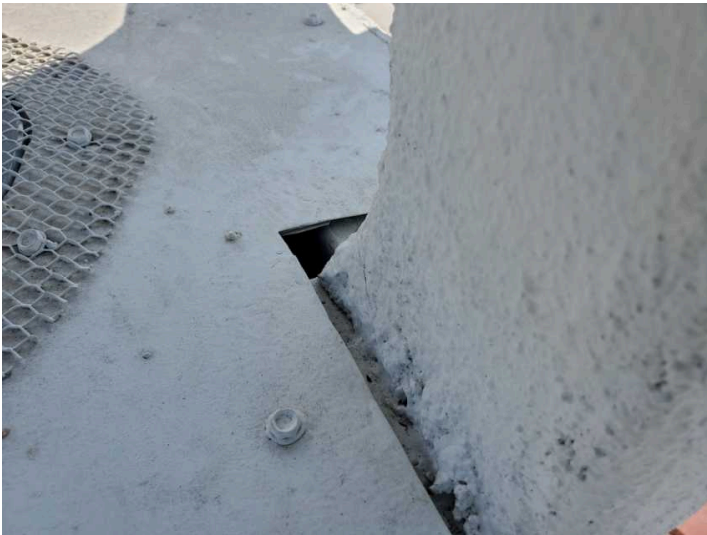
- IMPROVE: Chimney cap has gaps/improperly covered areas. Caps will help prevent intrusion into the chimney flue and possibly the structure interior by unwanted wildlife and rain. Recommend having the chimney cap/liner reviewed by a certified chimney sweep.
- Indications of dusted & missing mortar joints was observed at the bricks of the exterior chimney below the home. Further deterioration and expensive repairs to the masonry chimney may be the result of not having the mortar joints repaired. Recommendation is for a mason specialist to properly tuck point the damaged mortar joints.

Improperly covered area

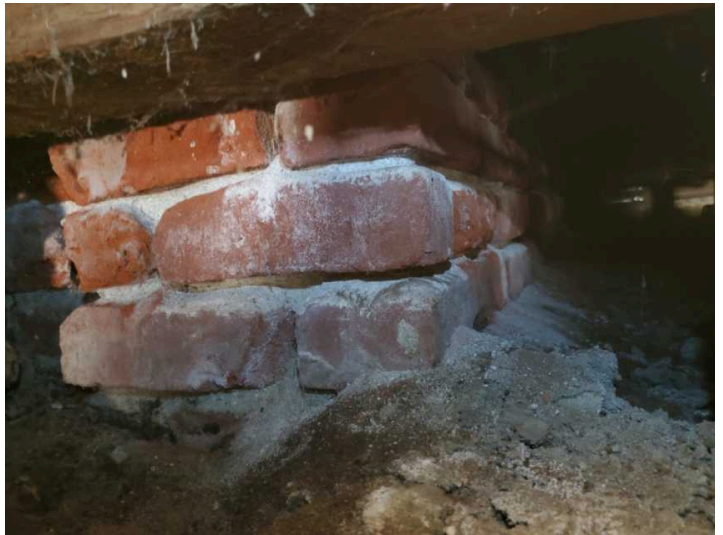
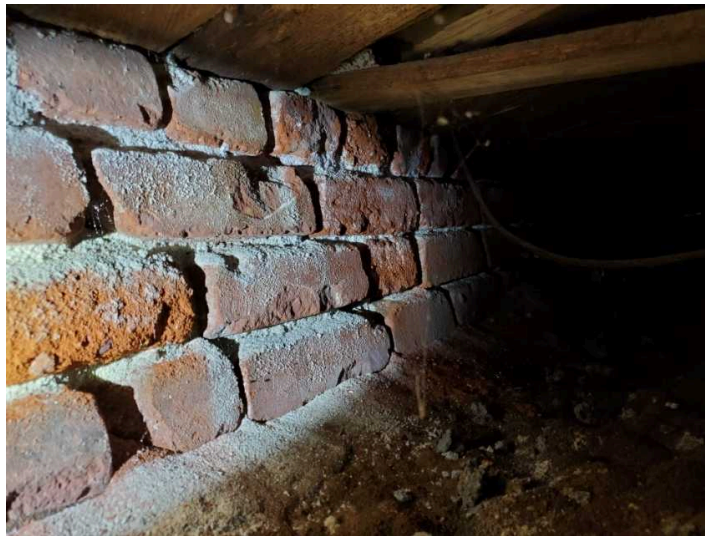
Mortar has dusted out

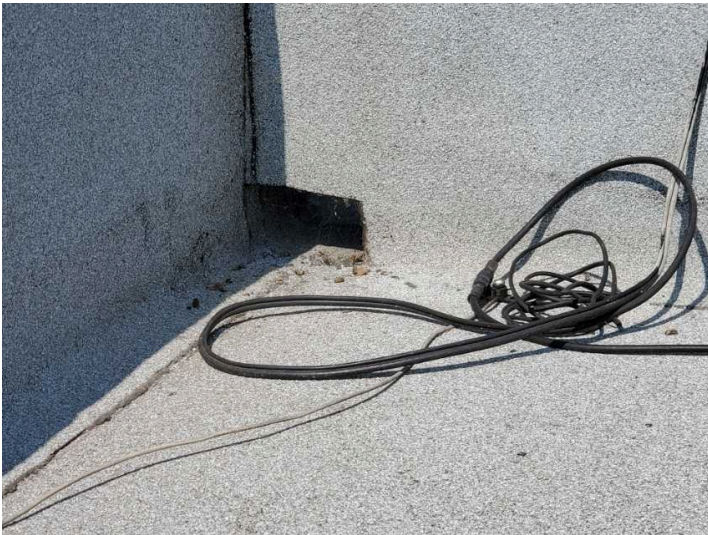
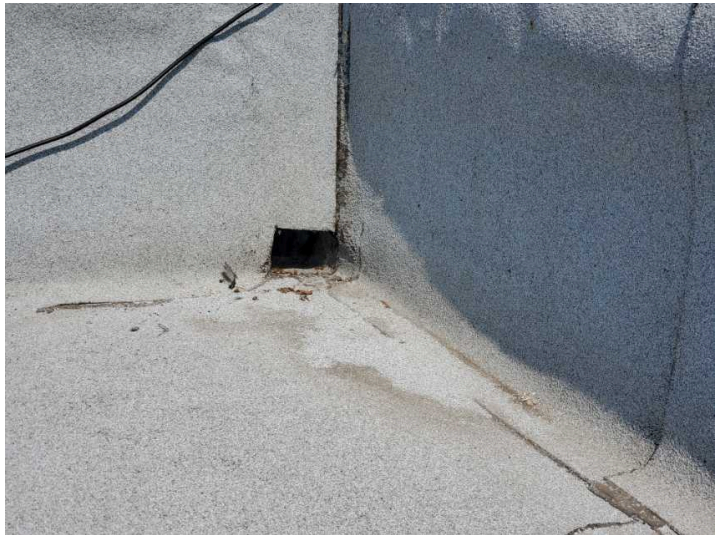
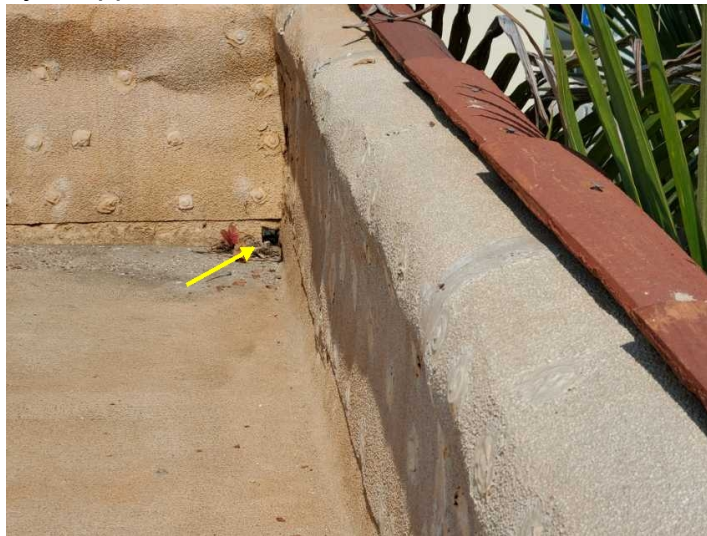
- The roof drainage system appeared in serviceable condition at time of inspection however the roof top scuppers/drains are not provided with secondary/emergency scuppers incase the primary scuppers/drains get blocked by debris. Recommend the roof be checked and cleared of any debris annually.

No secondary scupper

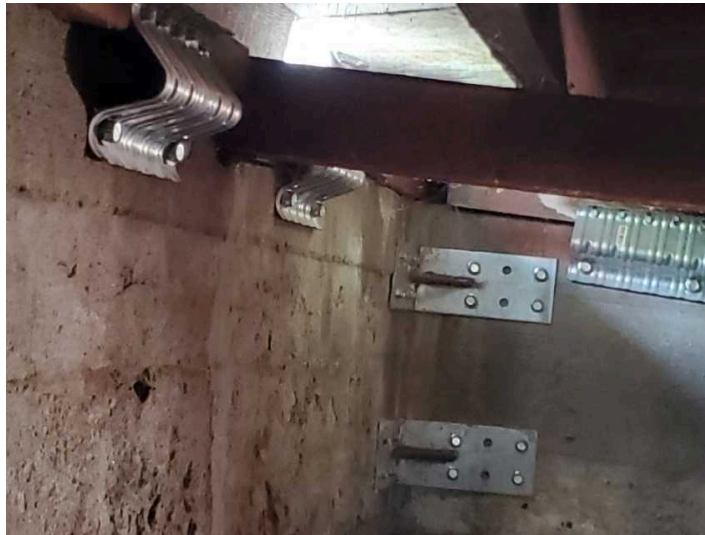
- Area of major repair noted to poured concrete foundation wall. Seismic bracing has been installed at all perimeter walls to help connect the house framing to the poured concrete foundation. This repair appears to be professionally done. Buyer is recommended to request and review any existing documents relative to this repair to determine if any warranties exist. No warranty for this or any other repair is implied by this inspection.

Retrofit seismic bracing and foundation wall reinforcing

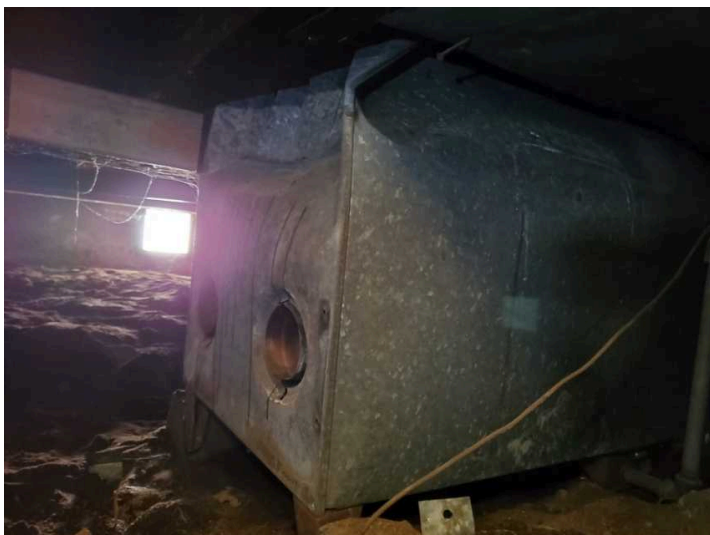
- Soil is damp throughout the crawlspace. Fungus growing at rear right corner of the crawlspace. Unable to determine the source of moisture. Recommend further evaluation by a qualified contractor to identify source of moisture and any remedies needed.
- Abandoned floor heater observed. This system no longer serves a purpose and it is recommended to be removed. A qualified contractor is recommended.

Abandoned floor furnace

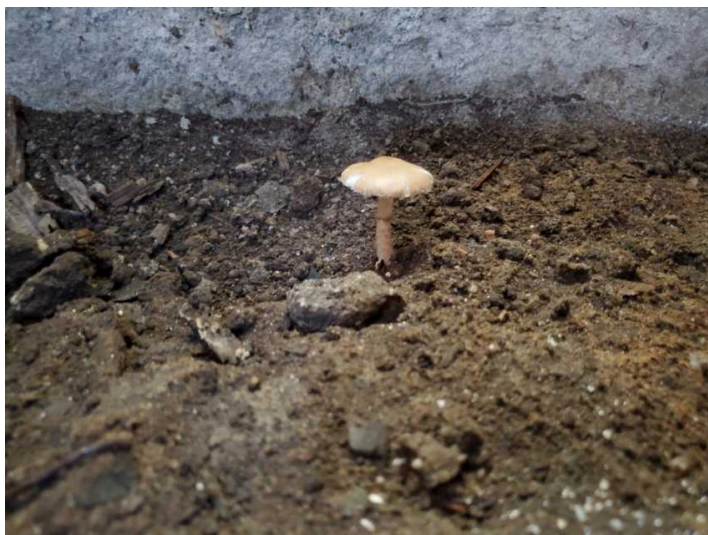
Fungus

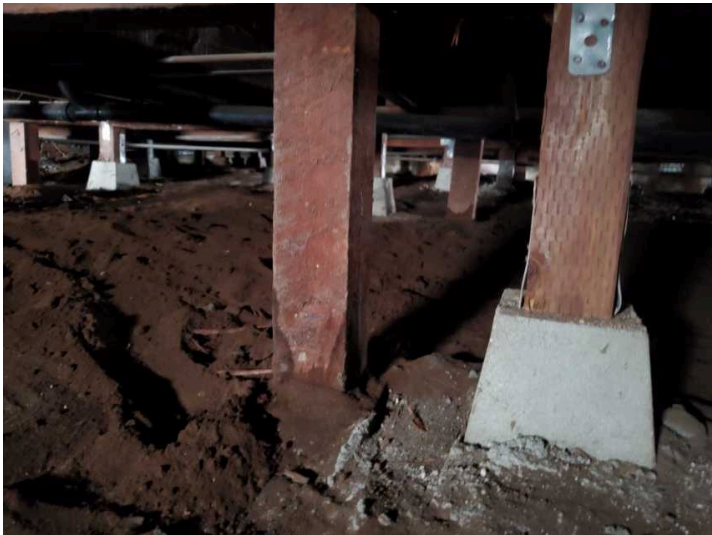
- Earth-to-wood contact noted with wood multiple posts. Wood members in contact with soil are susceptible to moisture damage and termite infestation. Concrete piers should support wood posts and extend a minimum of 6 inches above the soil grade. Recommend further evaluation by a qualified foundation contractor.

Earth-to-wood contact

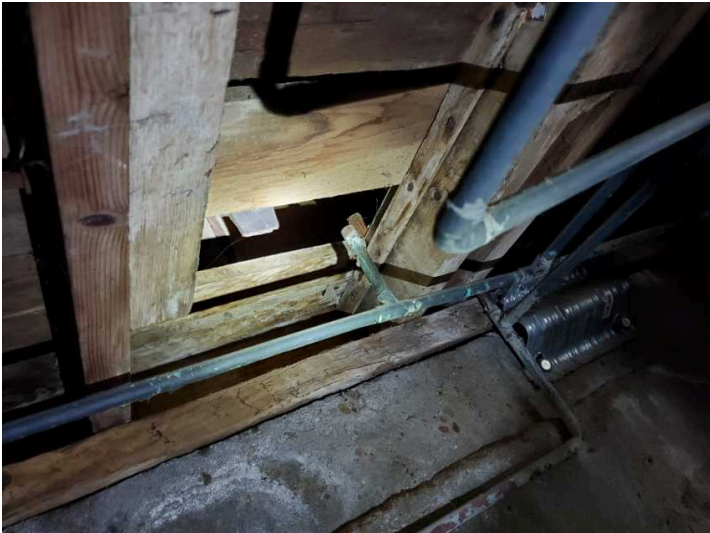
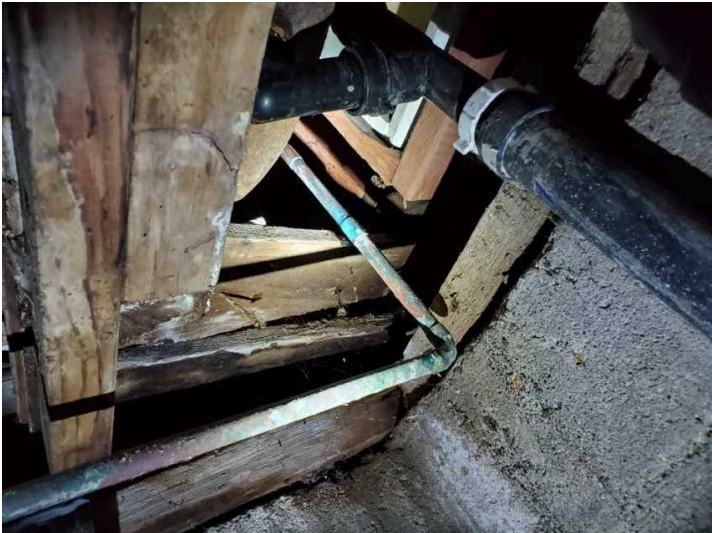
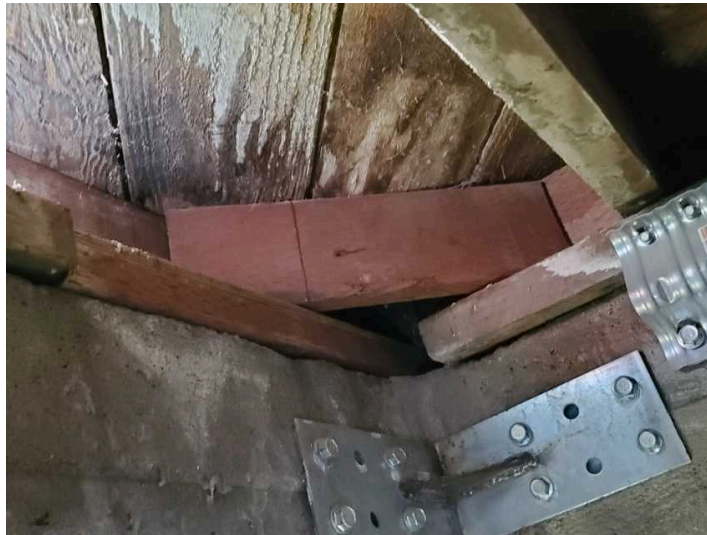
- Wood rot, previous moisture damage observed below tub. Most affected subfloor has been removed but not replaced with new subfloor. Some small sections of rotted subfloor have been left behind. Recommend further evaluation for any potential repairs or upgrades by a qualified contractor.
- Repairs noted to subfloor and sill plate at rear right corner of home. Unable to determine the effectiveness of these repairs. Inquire with the seller to ensure these repairs were performed by a qualified contractor.

Missing subfloor below tub

Rotted wood and missing subfloor below tub

Repairs at rear right corner of house subfloor and sill plate

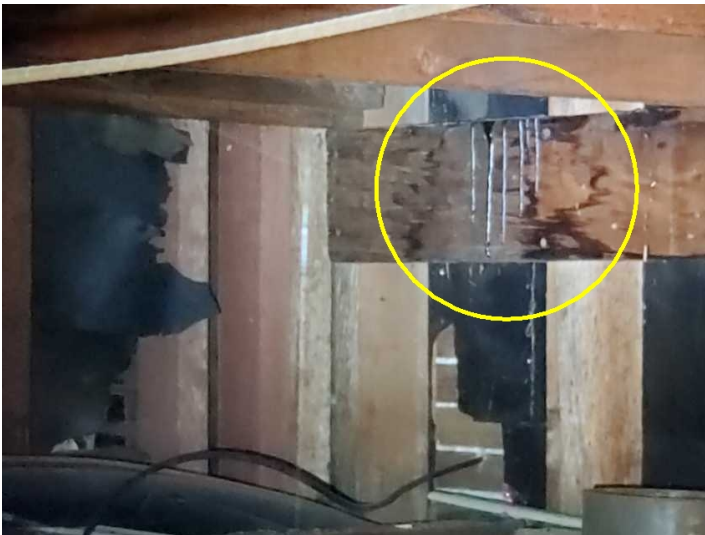
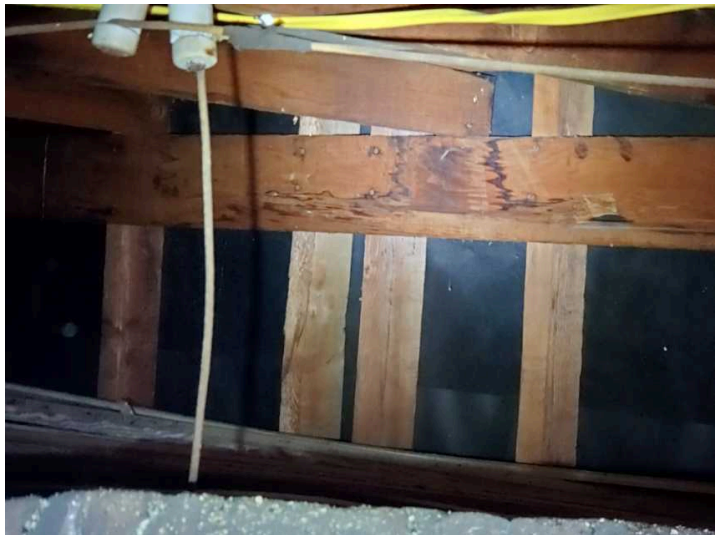
- Finished surfaces or insulation blocked our view of roof-to-wall connections. These connections were not confirmed. - If you have concerns about this, a full inspection would involve invasive or destructive testing, which is beyond the scope of this inspection.
- Stain(s) observed in the roof sheathing and/or framing at various areas in attic. Water stains on the ceilings, or on the framing within attics will not necessarily confirm an active leak. This roof may have had past repairs preformed since the roof covering was installed. The staining found in the attic may have resulted from previous roof leaks which may have been repaired. We recommend asking the seller if repairs were performed by a qualified licensed roof contractor.

Moisture stains

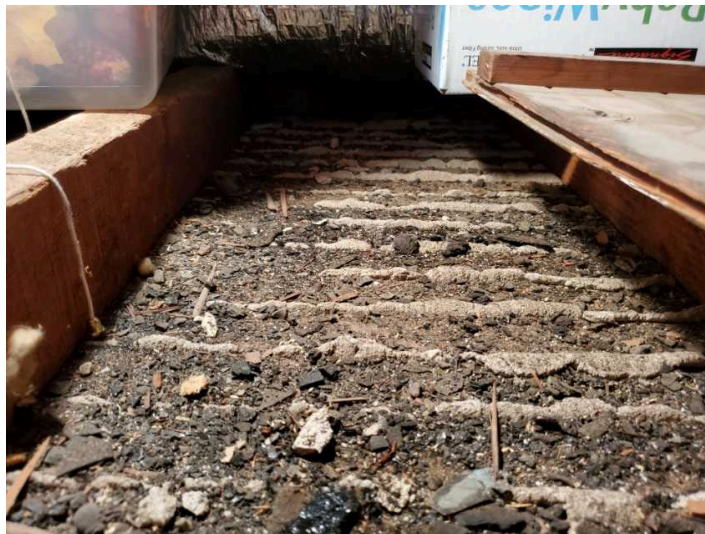
• IMPROVE: The house has no amount of visible insulation. Expect high heating and cooling energy costs. Recommend having the home professionally insulated to reduce energy expenses.

No insulation

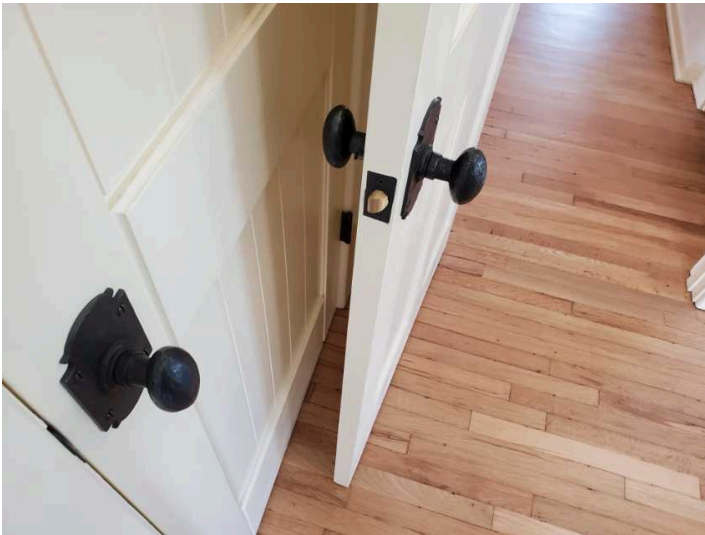
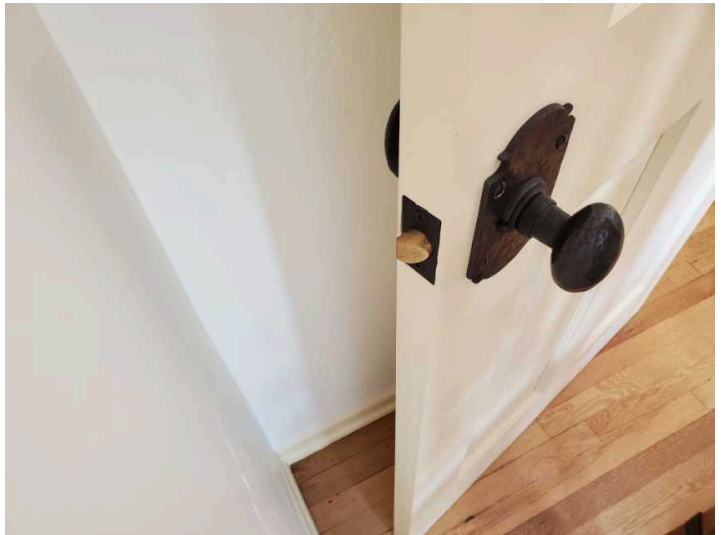
- The door stops are either damaged or missing. Damage could occur to the walls. Recommend installing protective door or wall protectors.

Missing doorstop

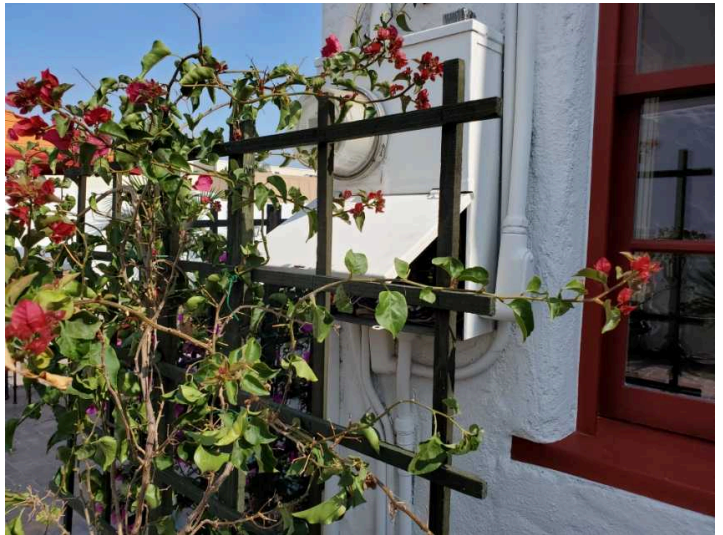
Panel obstructed

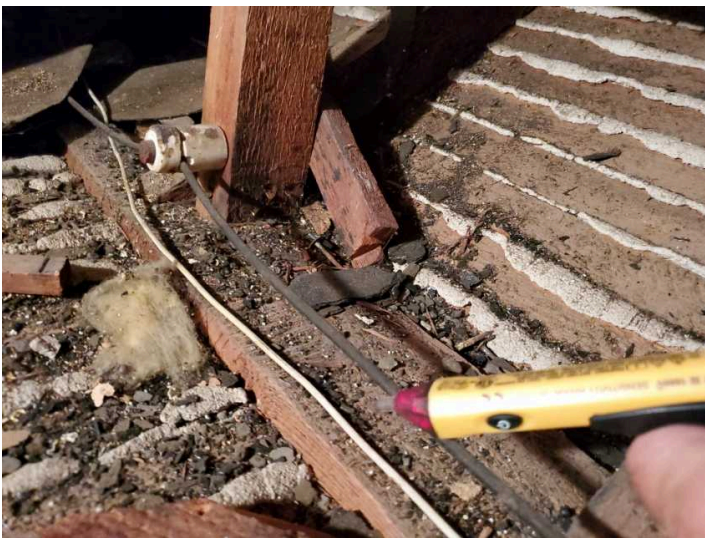
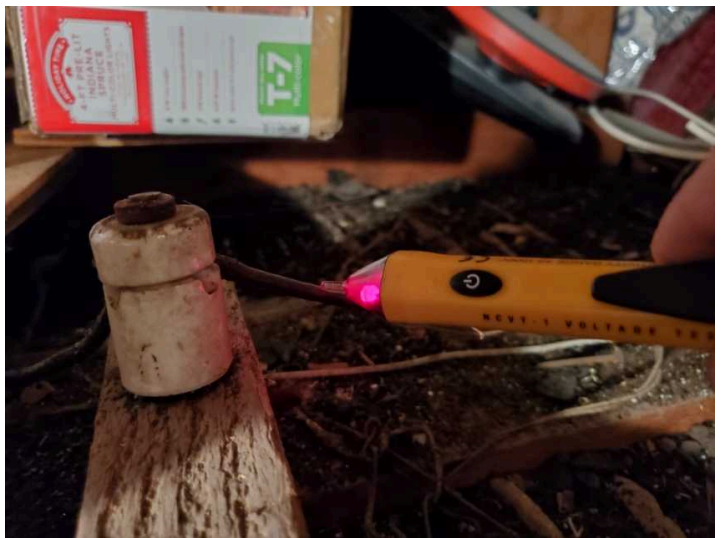
• **Deferred Cost:** Some wiring in this residence is wired with knob and tube wiring. Knob and tube wiring can be presumed to be the original electrical wiring in the home and old and outdated by today's safety standards. Problems with knob and tube wiring are as follows: (1) Limited wire size in this type of wiring system can cause wires to be loaded beyond safe capacity by the use of multiple modern appliances; (2) Repeated overheating of the wiring over the years can cause the protective wire insulation to harden, crack, and break off, leaving energized wires exposed to touch and creating a fire hazard; (3) Knob and tube wiring is designed to maintain a safe temperature by radiating heat into the surrounding air. Because it is common for insulation to be added to homes to save on heating costs, wires are often buried in insulation which may create a fire hazard. (4) Improperly splicing the wiring. I recommend replacing this outdated wiring system with modern wiring. You should consult with a qualified electrical contractor to determine options and costs. I am aware of some insurance companies that decline to provide homeowner's insurance if active knob & tube wiring is present. Recommend contacting preferred insurance company before close of escrow to ensure that appropriate homeowner's insurance can be obtained on the structure. Recommend further evaluation by licensed electrician before close of escrow.

Energized K&T wiring

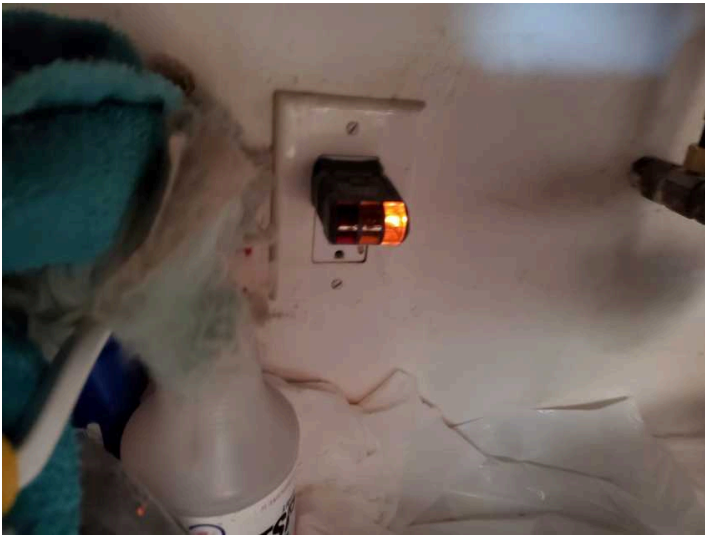
• Receptacle below the kitchen sink may not be wired properly. This receptacle is powered by a wall switch and the garbage disposal is plugged into it. With the switch off and the disposal plugged in, a standard receptacle tester was used and an error light indicating the hot and ground are reversed. With the disposal unplugged, an open neutral is indicated at the standard receptacle tester. Recommend further review by a qualified electrician.

Open neutral

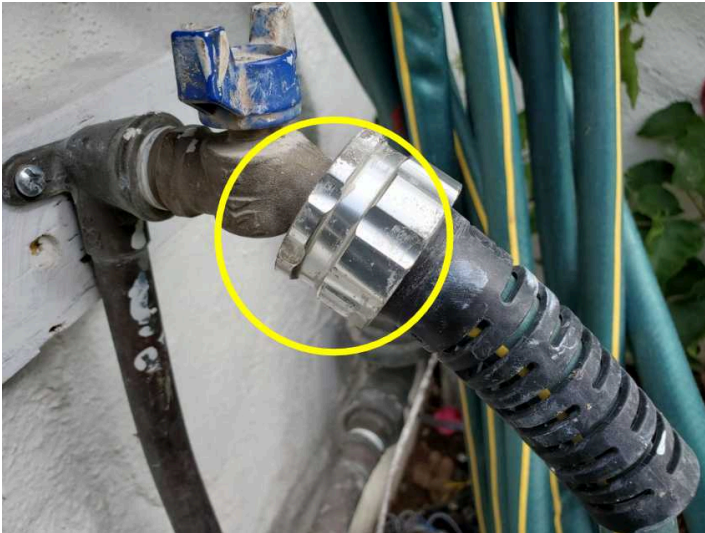
- IMPROVE: There are no anti siphon devices at some exterior faucets. Although this was not a requirement for when this house was constructed, it is recommended that these devices be installed at all exterior hose bibs. These are designed to prevent contamination should there be a pressure drop in the cities system. Anti-siphon devices will prevent water from being siphoned backwards potentially contaminating the public drinking water. Recommend installation of these devices.

Missing anti-siphon valve

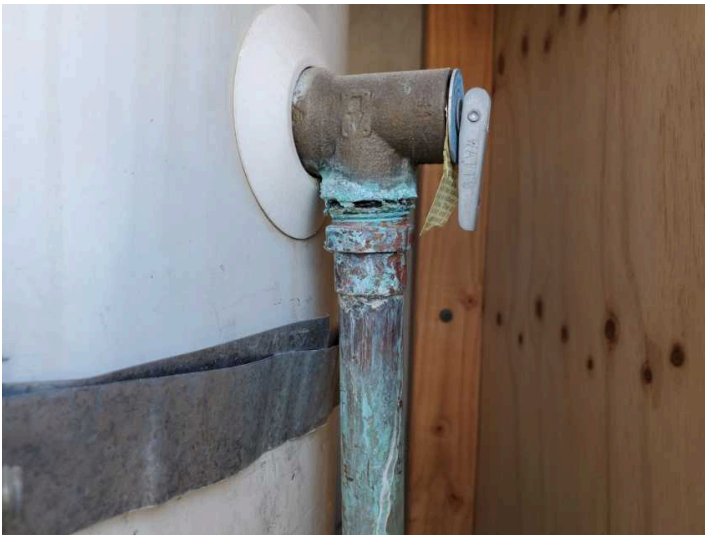
- The water heater is strapped.
- Corrosion observed at the water heater relief valve. Water streaks are observed. No water was detected however there is a high likelihood this area has leaked in the past or is at risk of leaking in the near future. Recommend further review for repairs or replacement by a qualified plumber.
- Missing Insulation. The water supply lines were not insulated. The first 5 feet of hot and cold water pipes are required to be insulated if they are exposed in unconditioned space. It is recommended that these lines be properly insulated.
- The extension at the water heater relief valve ends prematurely. This is a potential scalding concern as water can discharge improperly. Recommend installing the proper type of relief extension to discharge within 6" from the floor. A qualified plumber is needed.

Corrosion

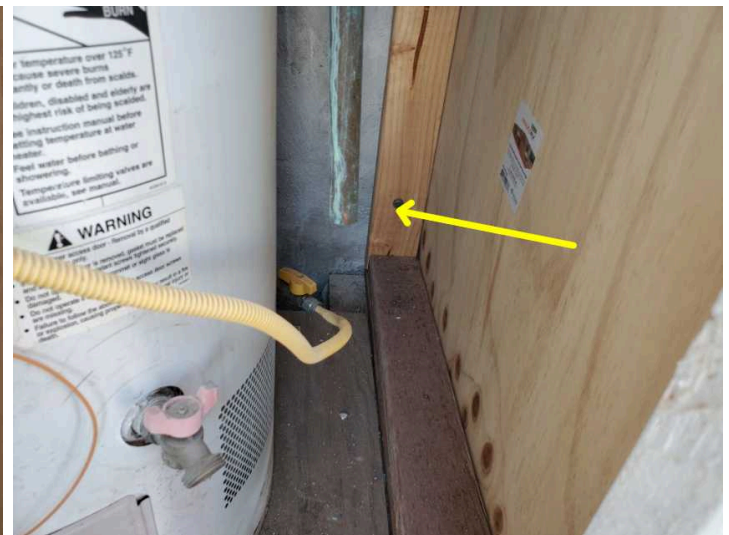
TPRV extension ends prematurely

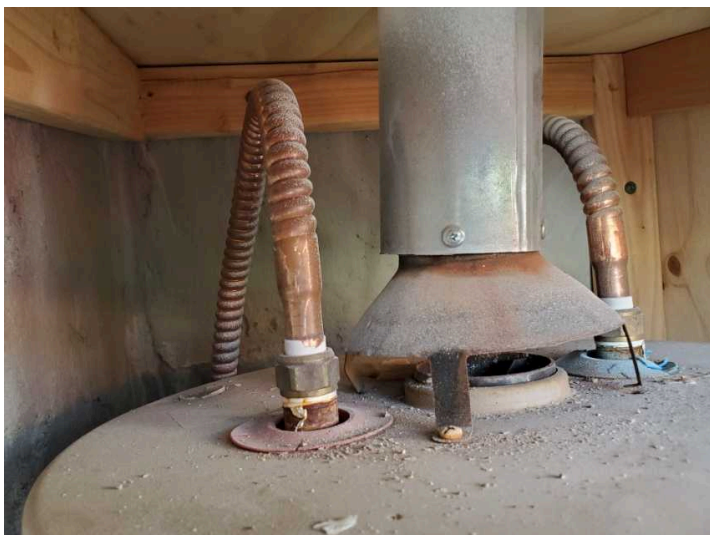
No insulation

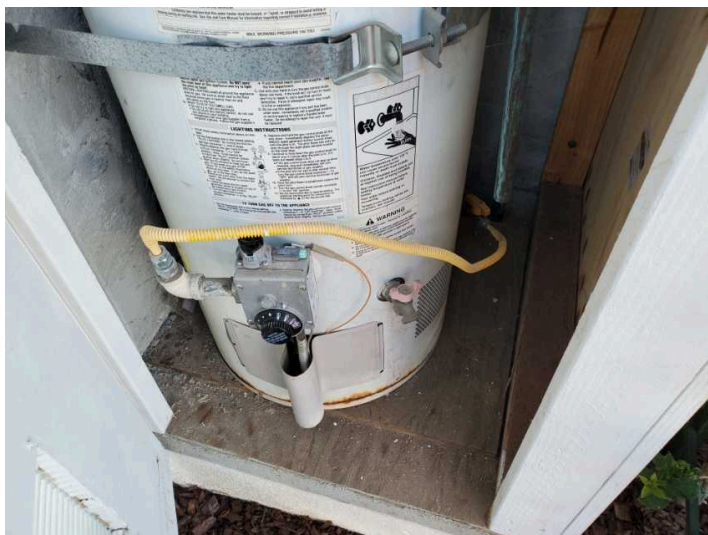
Missing sediment trap

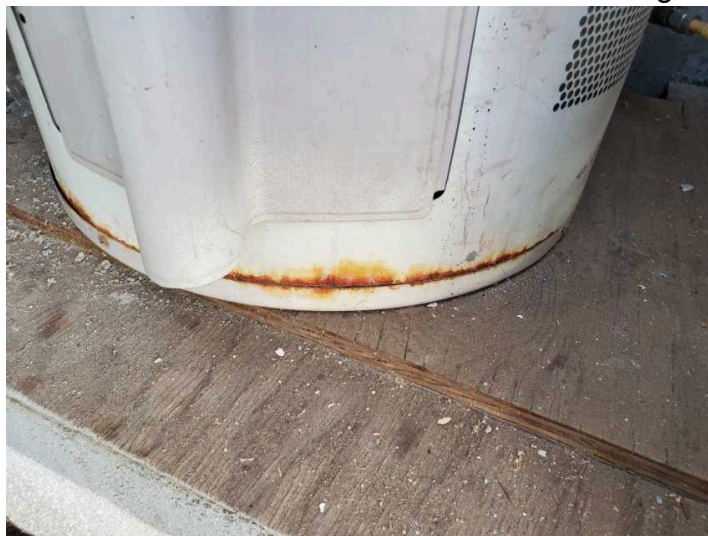
Tank is rusted

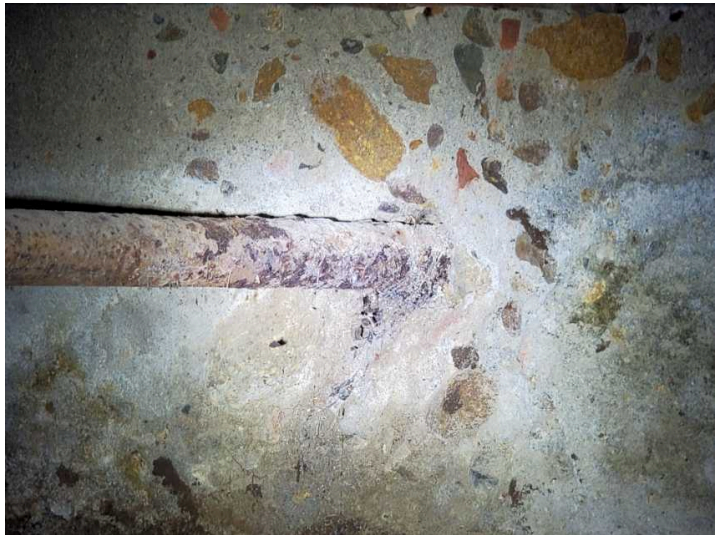
- Public utility gas meter. Interior gas lines were not fully visible. Gas lines are rigid iron pipe. The life expectancy of the gas piping is for the life of the structure.
- Poor piping support. Several sections of fuel piping could benefit from additional support. Recommend further evaluation by a qualified plumber.
- Abandoned floor heater observed with fuel line still attached. Unable to determine if fuel service is still provided to this equipment. Recommend further review for capping off or removal of the equipment and associated fuel lines. A qualified HVAC contractor is recommended.
- Rust or corrosion was observed at the gas line as it passes through the foundation wall unprotected. This condition can lead to gas leaks which can prove to be a safety hazard. I recommend further evaluation by a licensed plumber and repair as necessary for safety.

Fuel line rusted and not properly sleeved/protected

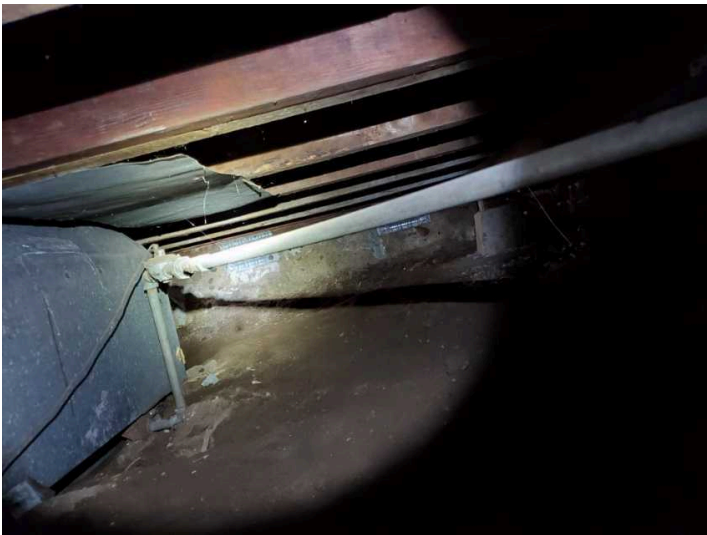
Fuel line attached to abandoned heater

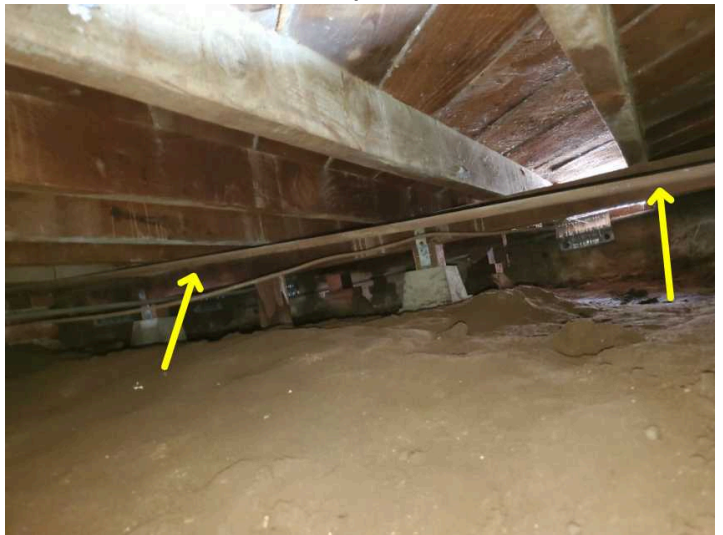
Fuel line not properly supported

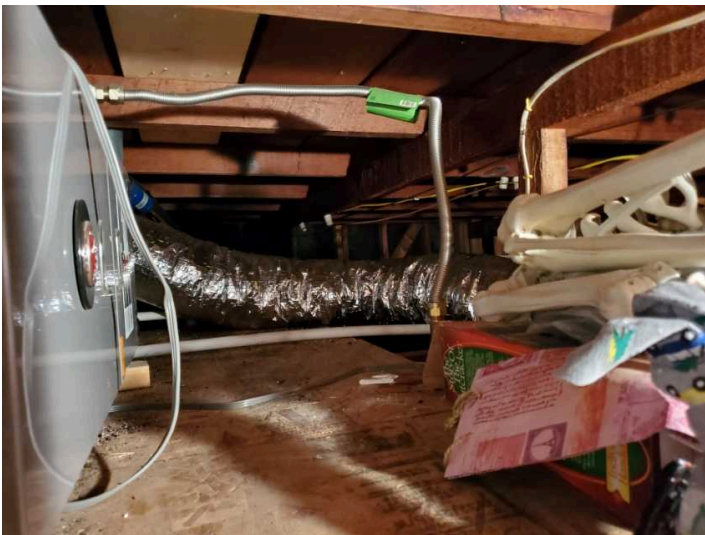
- NOTE: Gas Furnace- Limited Inspection. The Scope of this inspection does not include a thorough analysis of the inner components of the furnace. This includes but is not limited to cracks in the heat exchanger and areas of the heater that are not accessible. The average live expectancy for gas fired furnaces is typically considered to be about 15-20 years depending on use. It is recommended that all heaters be thoroughly evaluated by a licensed HVAC specialist every year to ensure proper working conditions.
- Furnace gas supply line missing sediment trap. This trap serves as a collection area for sediment to reduce the chance of clogged gas valves or burners. recommend installation by a qualified HVAC contractor.

Missing sediment trap
